# Pilot safety: a crucial component of navigational safety

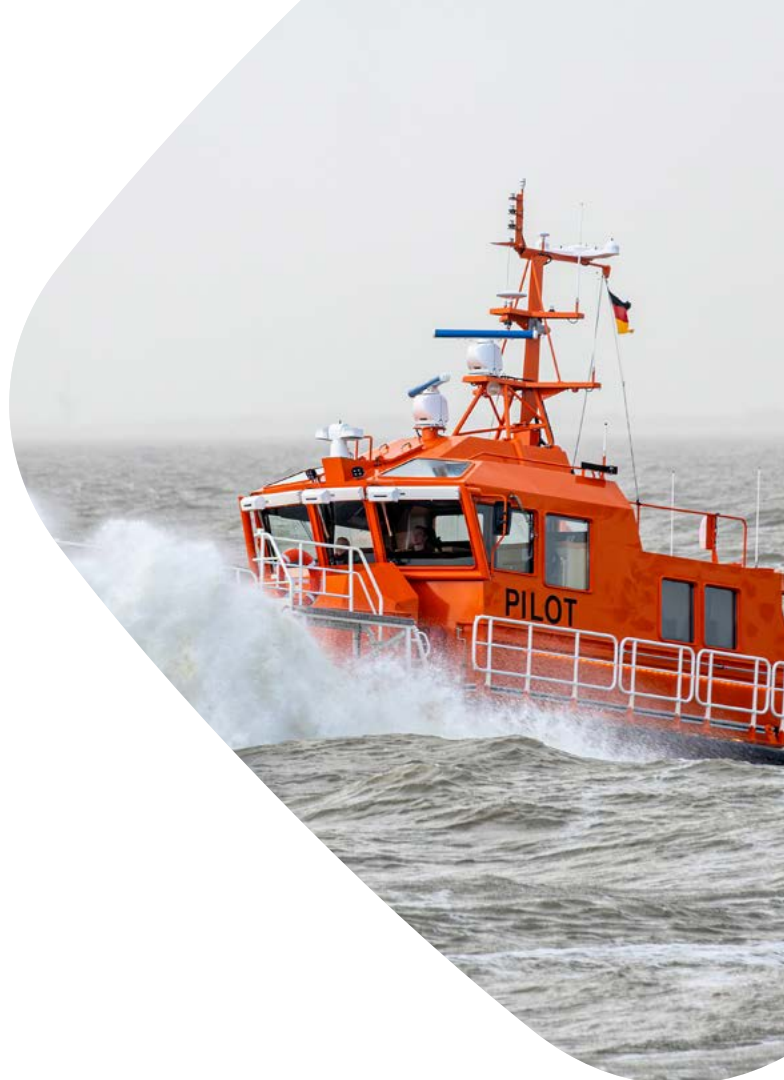
Moreover, the rigging of boarding arrangements prior to use is to be done by trained personnel, and the equipment used for this rigging is to be inspected and tested before use. This rigging, as well as the actual embarkation or disembarkation of the pilot, should be supervised on site by a responsible ship's officer with means of direct communication with the navigation bridge. A Risk Assessment is recommended to be performed beforehand which should reflect all these factors.

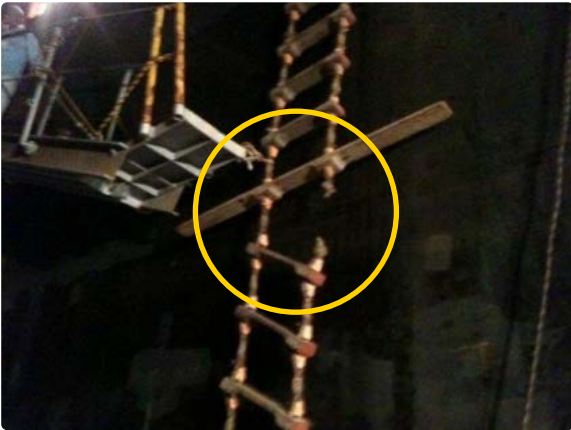
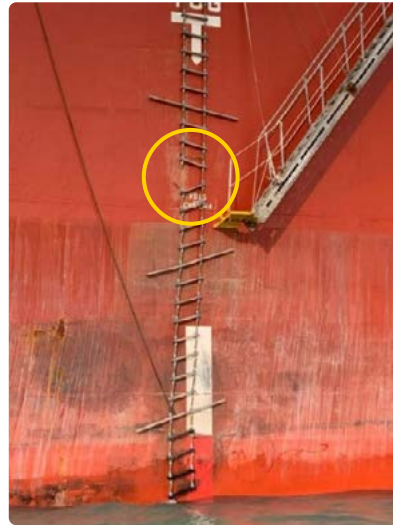
- **Damaged ladders**

The fact that the vessels' crews even deemed it appropriate to rig these ladders, shows a fundamental lack of safety awareness on their part, to say the very least.

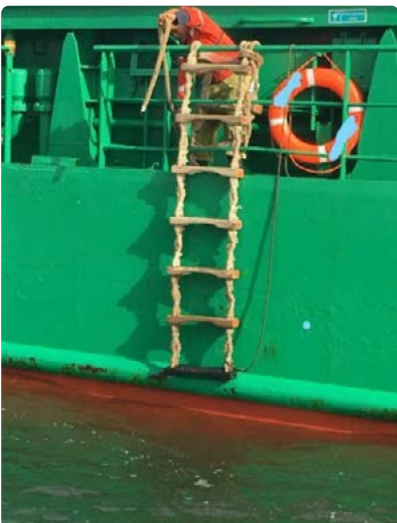
- **Wrong equipment and wrong rigging**

This arrangement does not provide proper and safe access to the vessel.

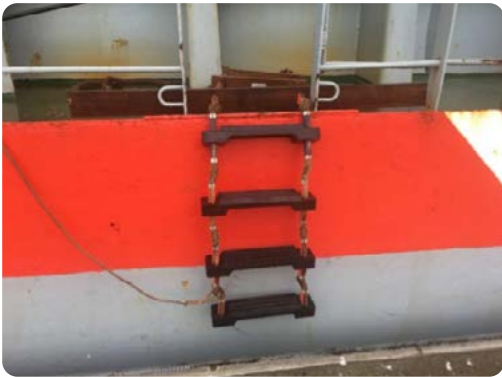
- **Wrong rigging**

The ladder's spreader is wrongfully used to 'secure' the ladder.

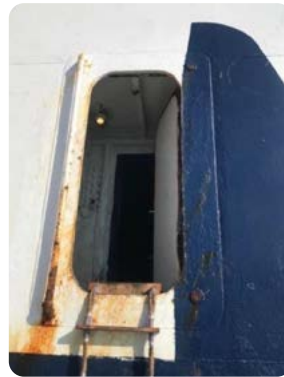
There are no stanchions provided.

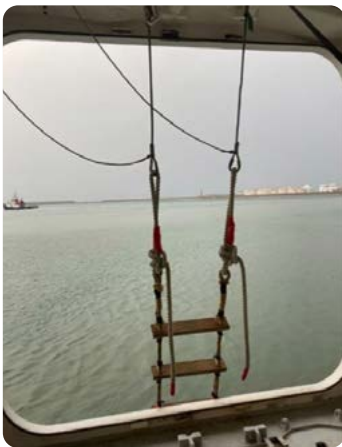
There are no stanchions, the ladder is not secured to the deck, and there is a trip hazard as the pilot needs to 'crawl' onto deck.

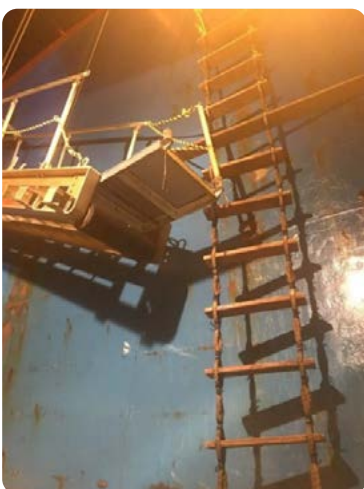
- **Non-compliant combinations**

The gangway's lower platform is not provided with outer stanchion and horizontal guard line. Furthermore, the pilot ladder is tied to the gangway, whereas both the gangway's lower platform and the pilot ladder should have been independently secured to the hull.
